Investigating benefits & limitations of smart technology

TO IMPROVE WASTE COLLECTION IN METRO VANCOUVER

2022 SWANA Canadian Symposium

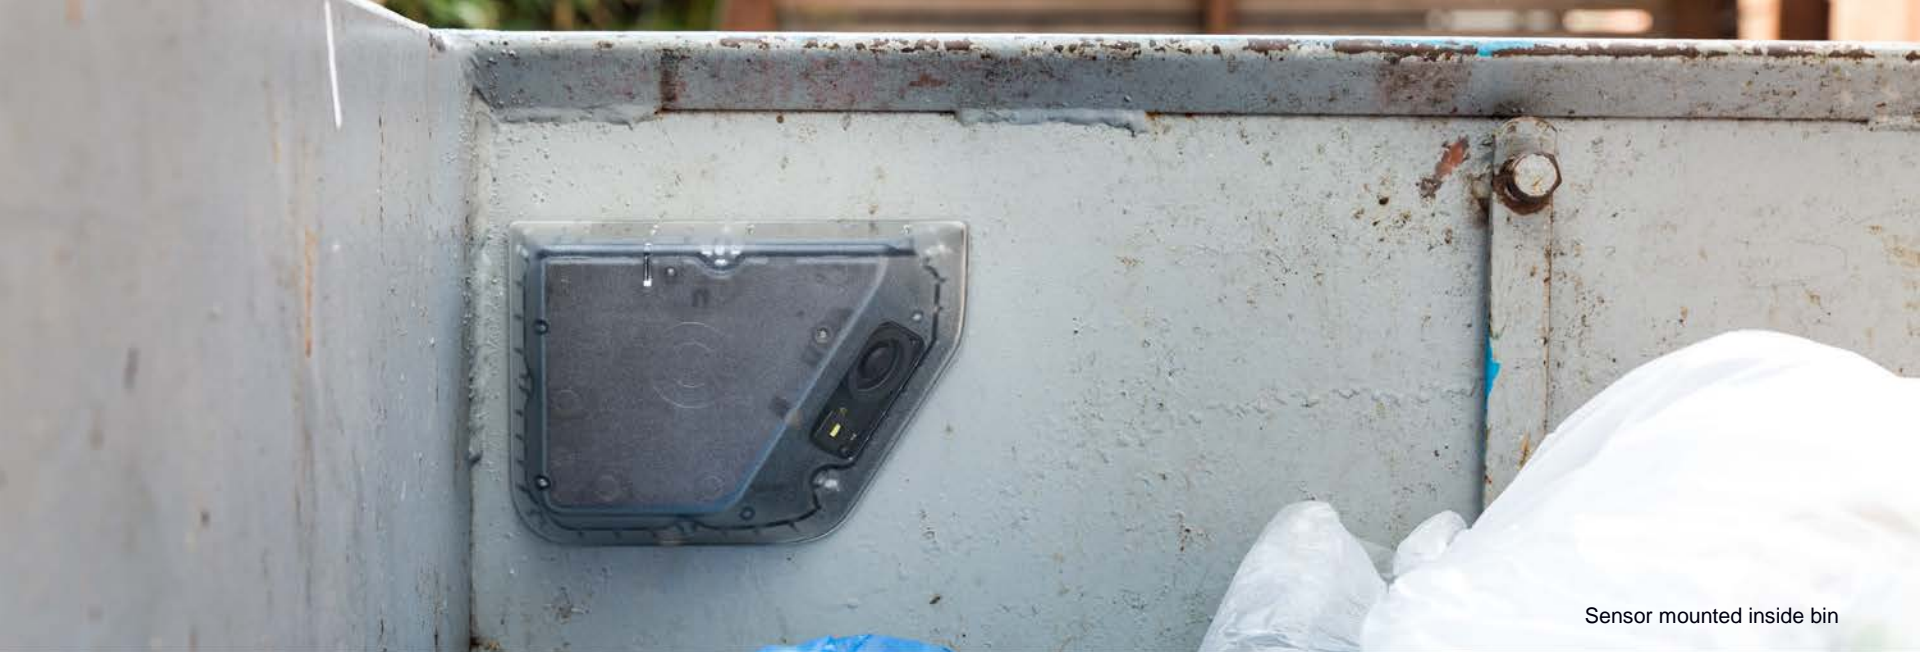
Sensor mounted inside bin

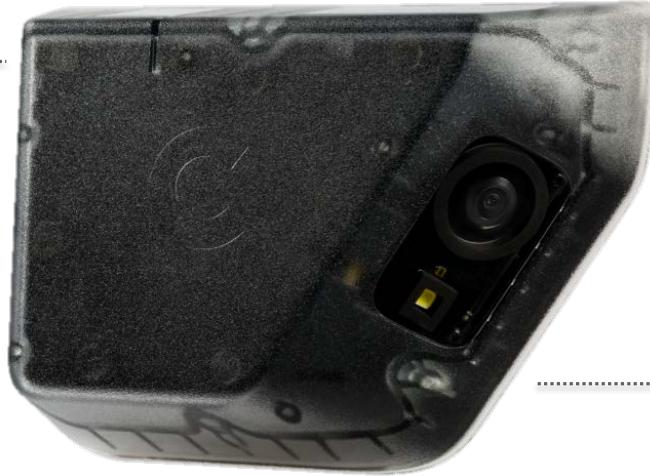
CAMERA BASED SENSORS

**Contamination
Monitoring**

**Service
Confirmation**

**Fullness
Monitoring**

**Customized
Reports**

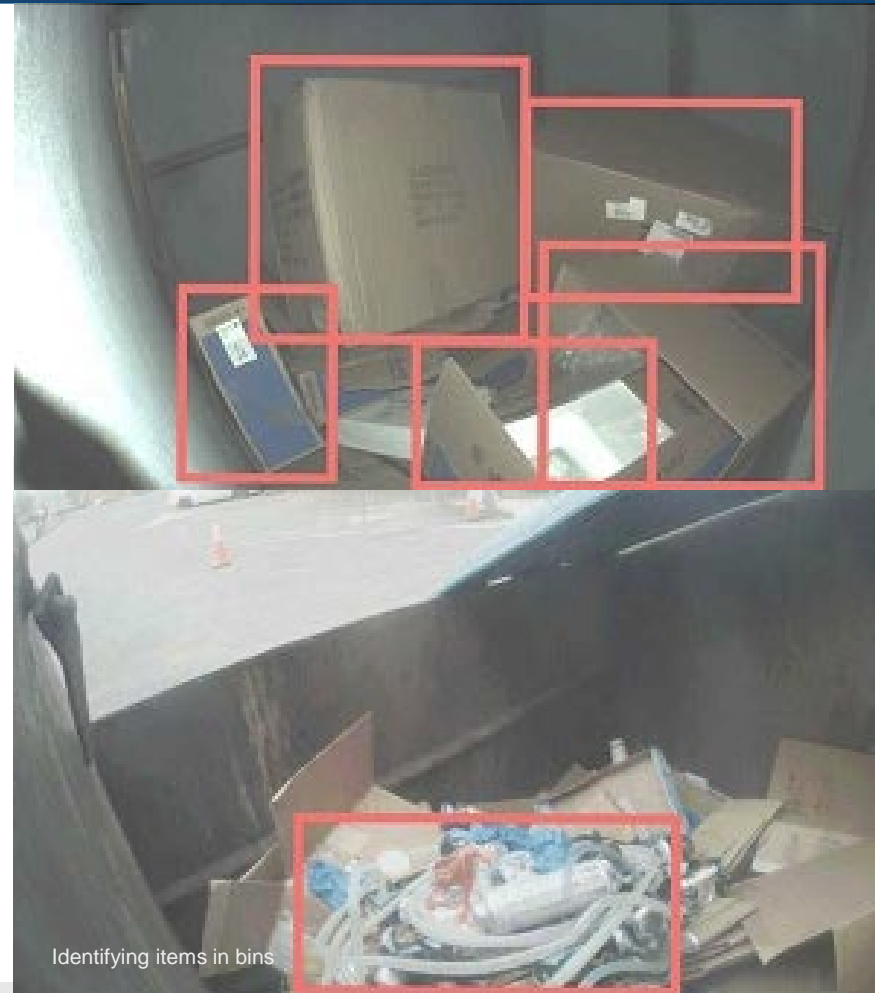
Identifying items in bins

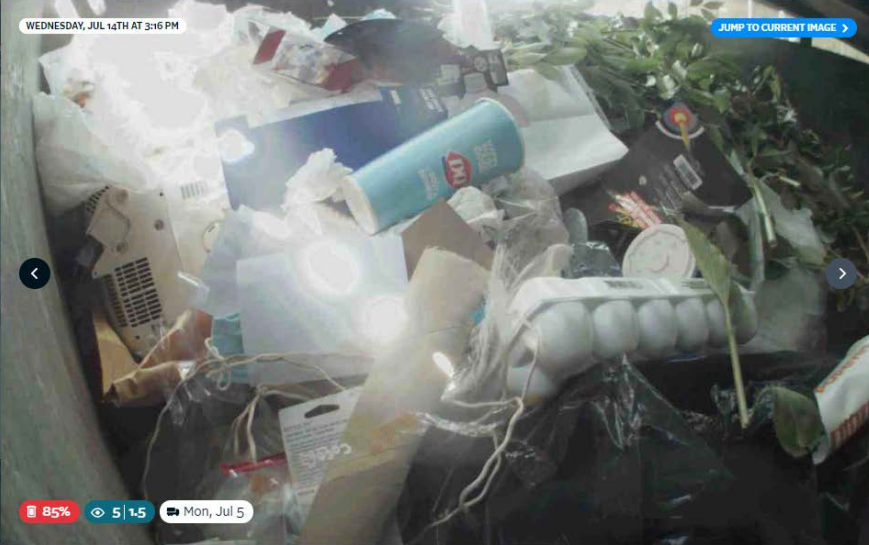
CONTAINER PAGE

CONTAMINATION IN CURRENT FILL CYCLE

1 UNCOLLAPSED CARDBOARD BOX

2 E-WASTE

3 STYROFOAM

4 BULKY ITEM

5 TANGLEDERS

6 CONSTRUCTION & YARD DEBRIS

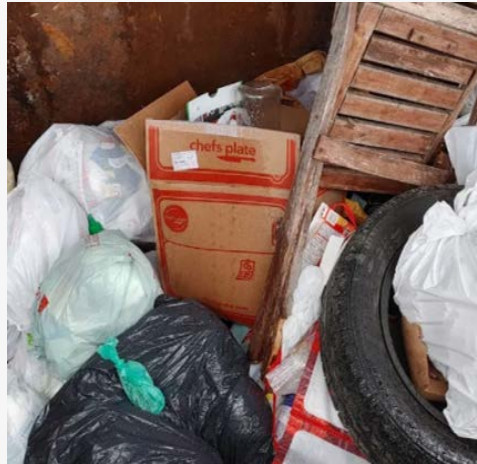
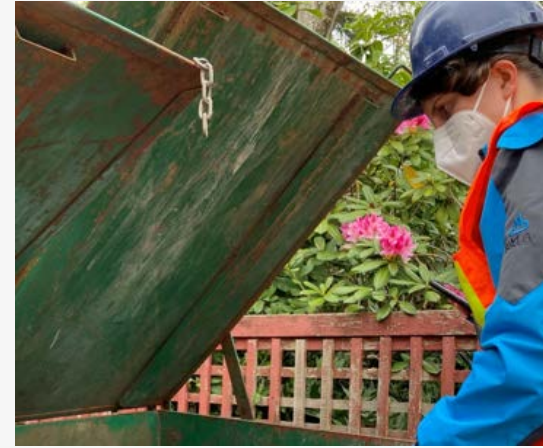
VISUAL AUDITS

- The auditor assessed the containers in-person according to Metro Vancouver's materials banned from disposal.

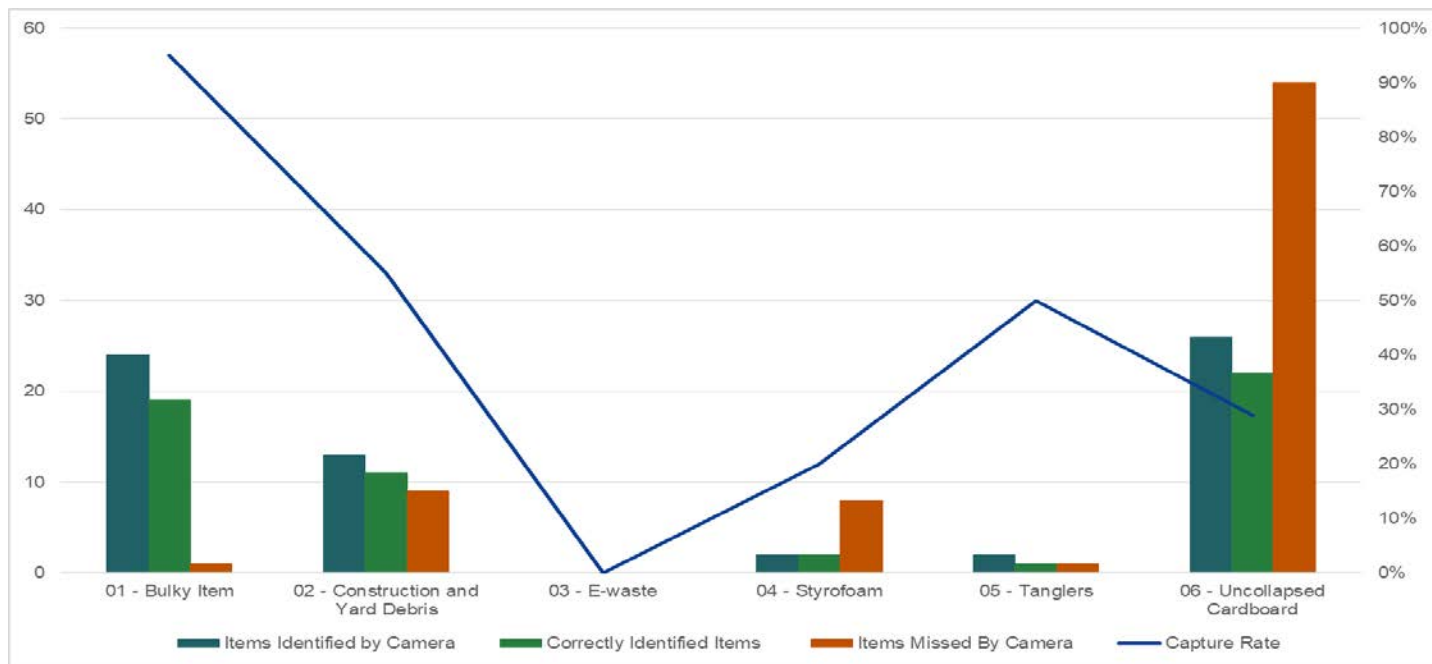
RESULTS

- Overall success rate of **43%** at identifying banned items
- **88%** correlation with human auditor on fullness levels
