Ashes to Action: Managing the Wolf Fire Disaster Response

SWANA NLC Annual Conference

April 2026

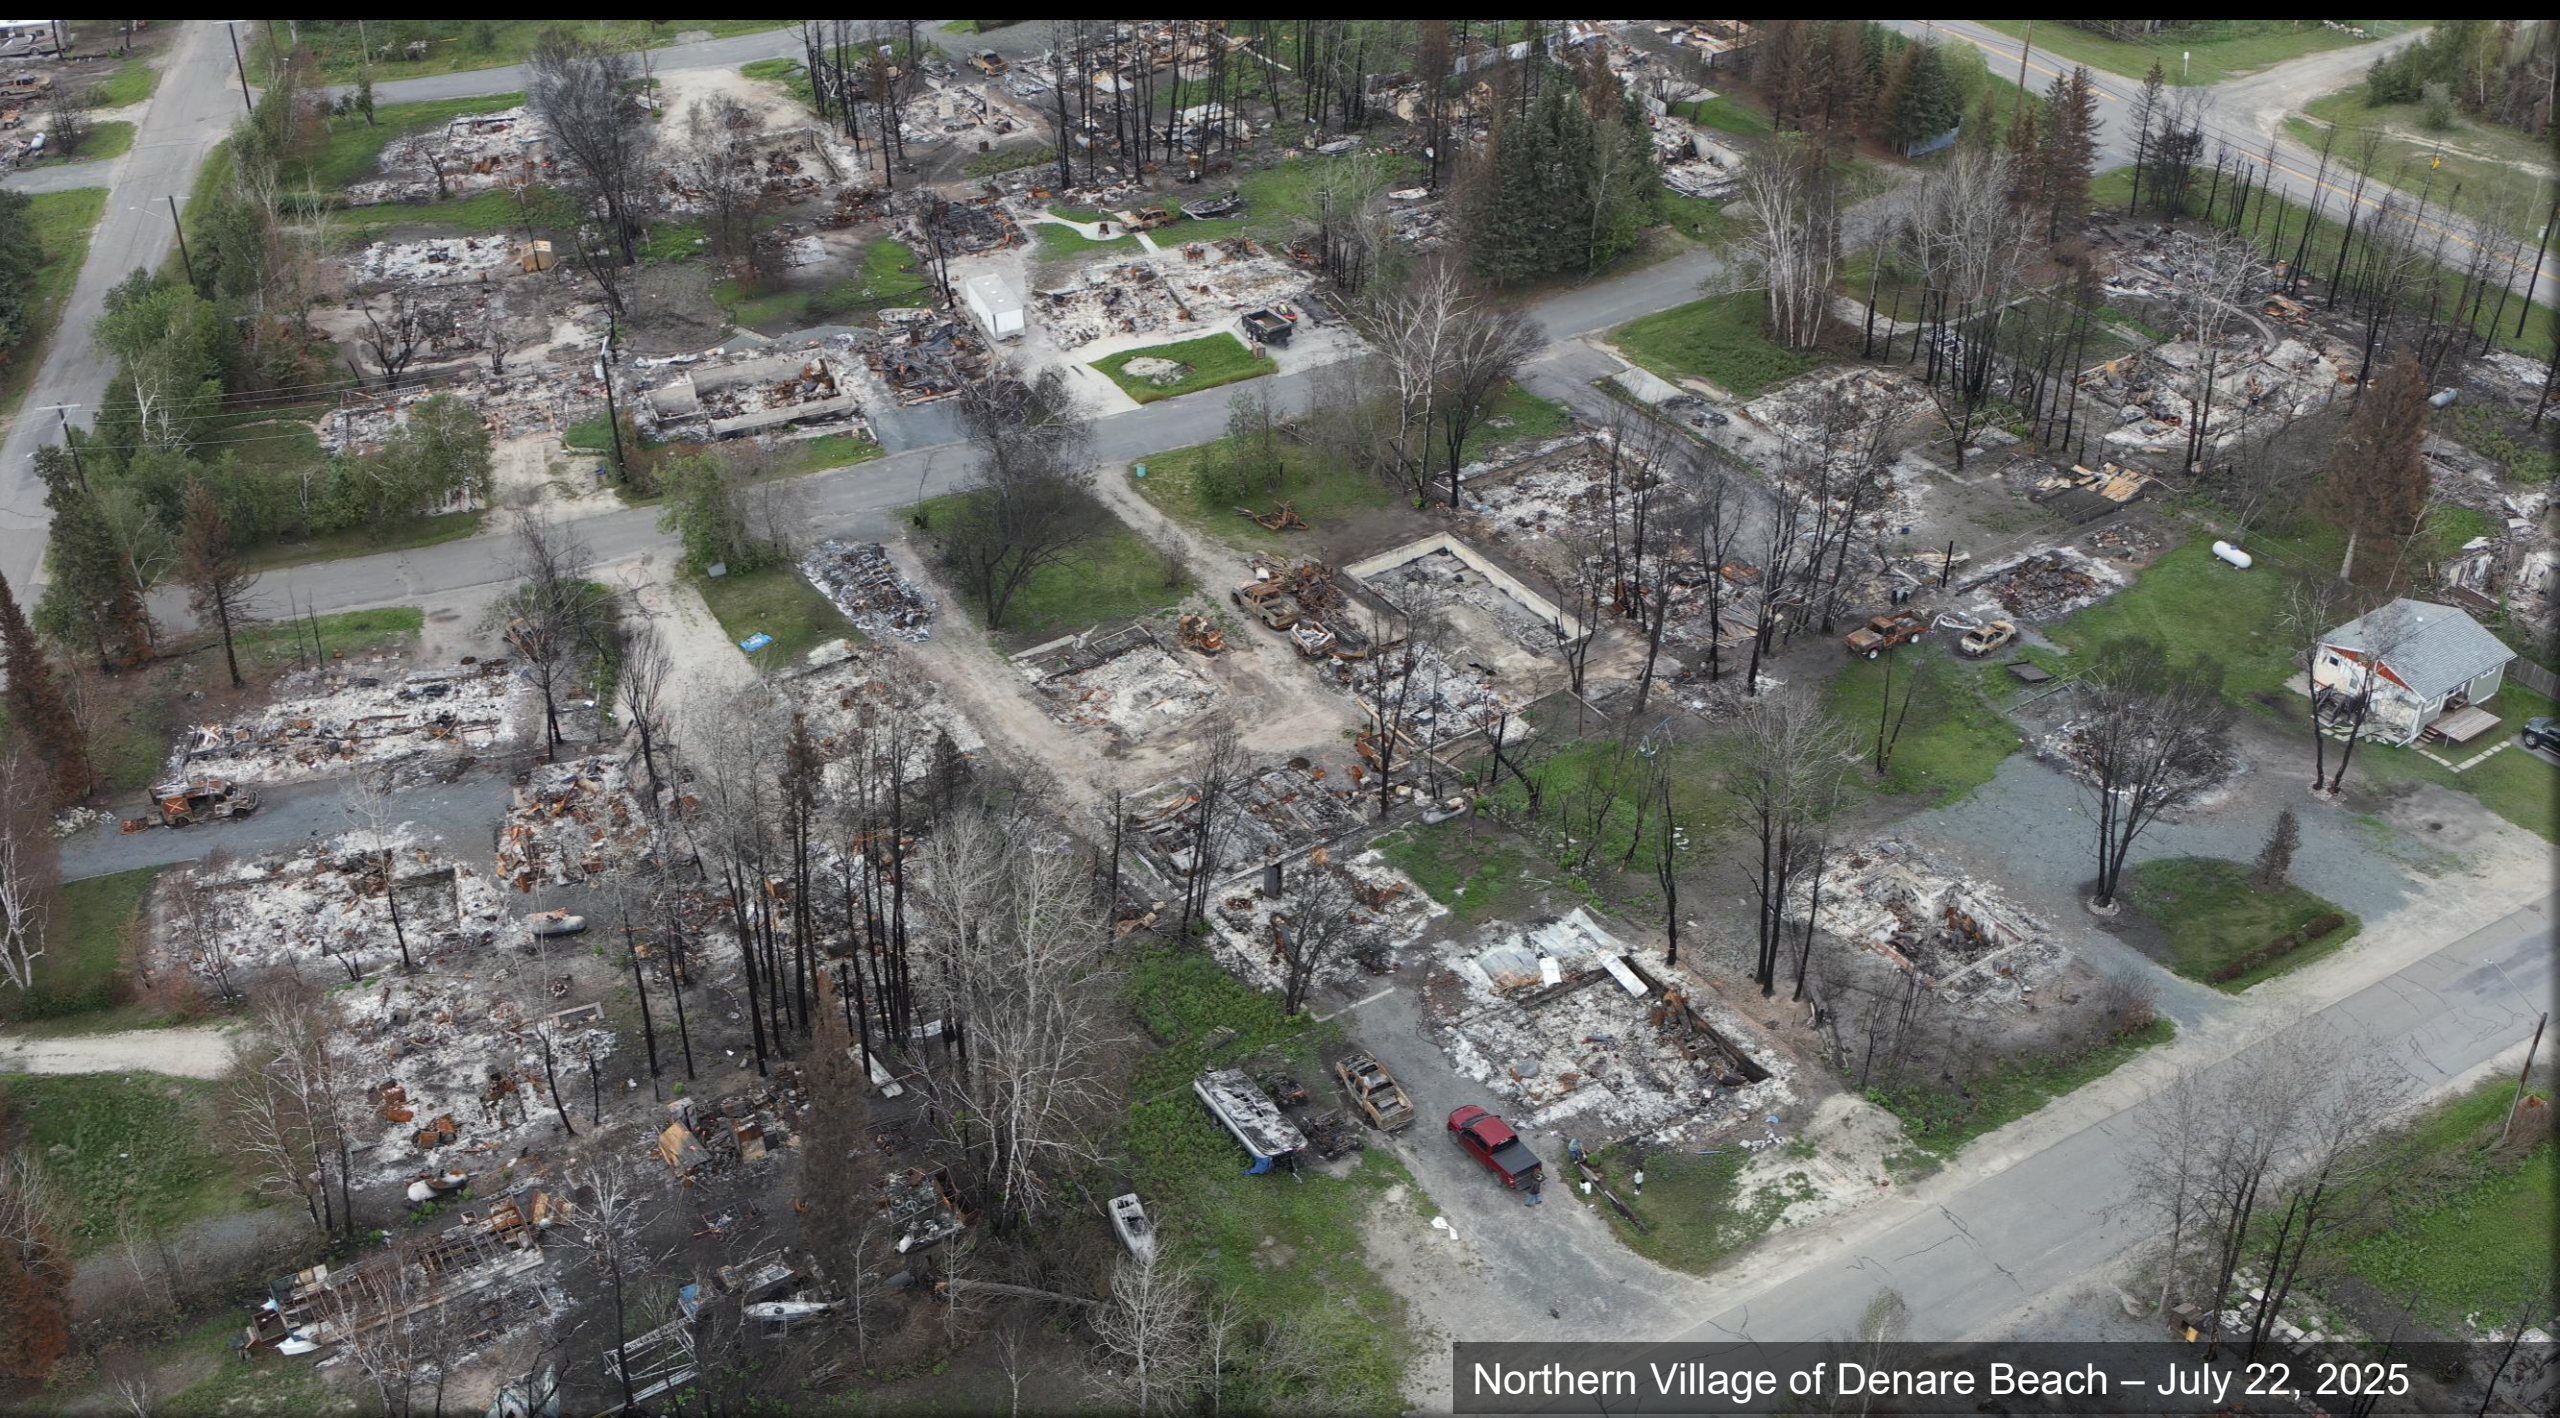
Northern Village of Denare Beach – July 22, 2025

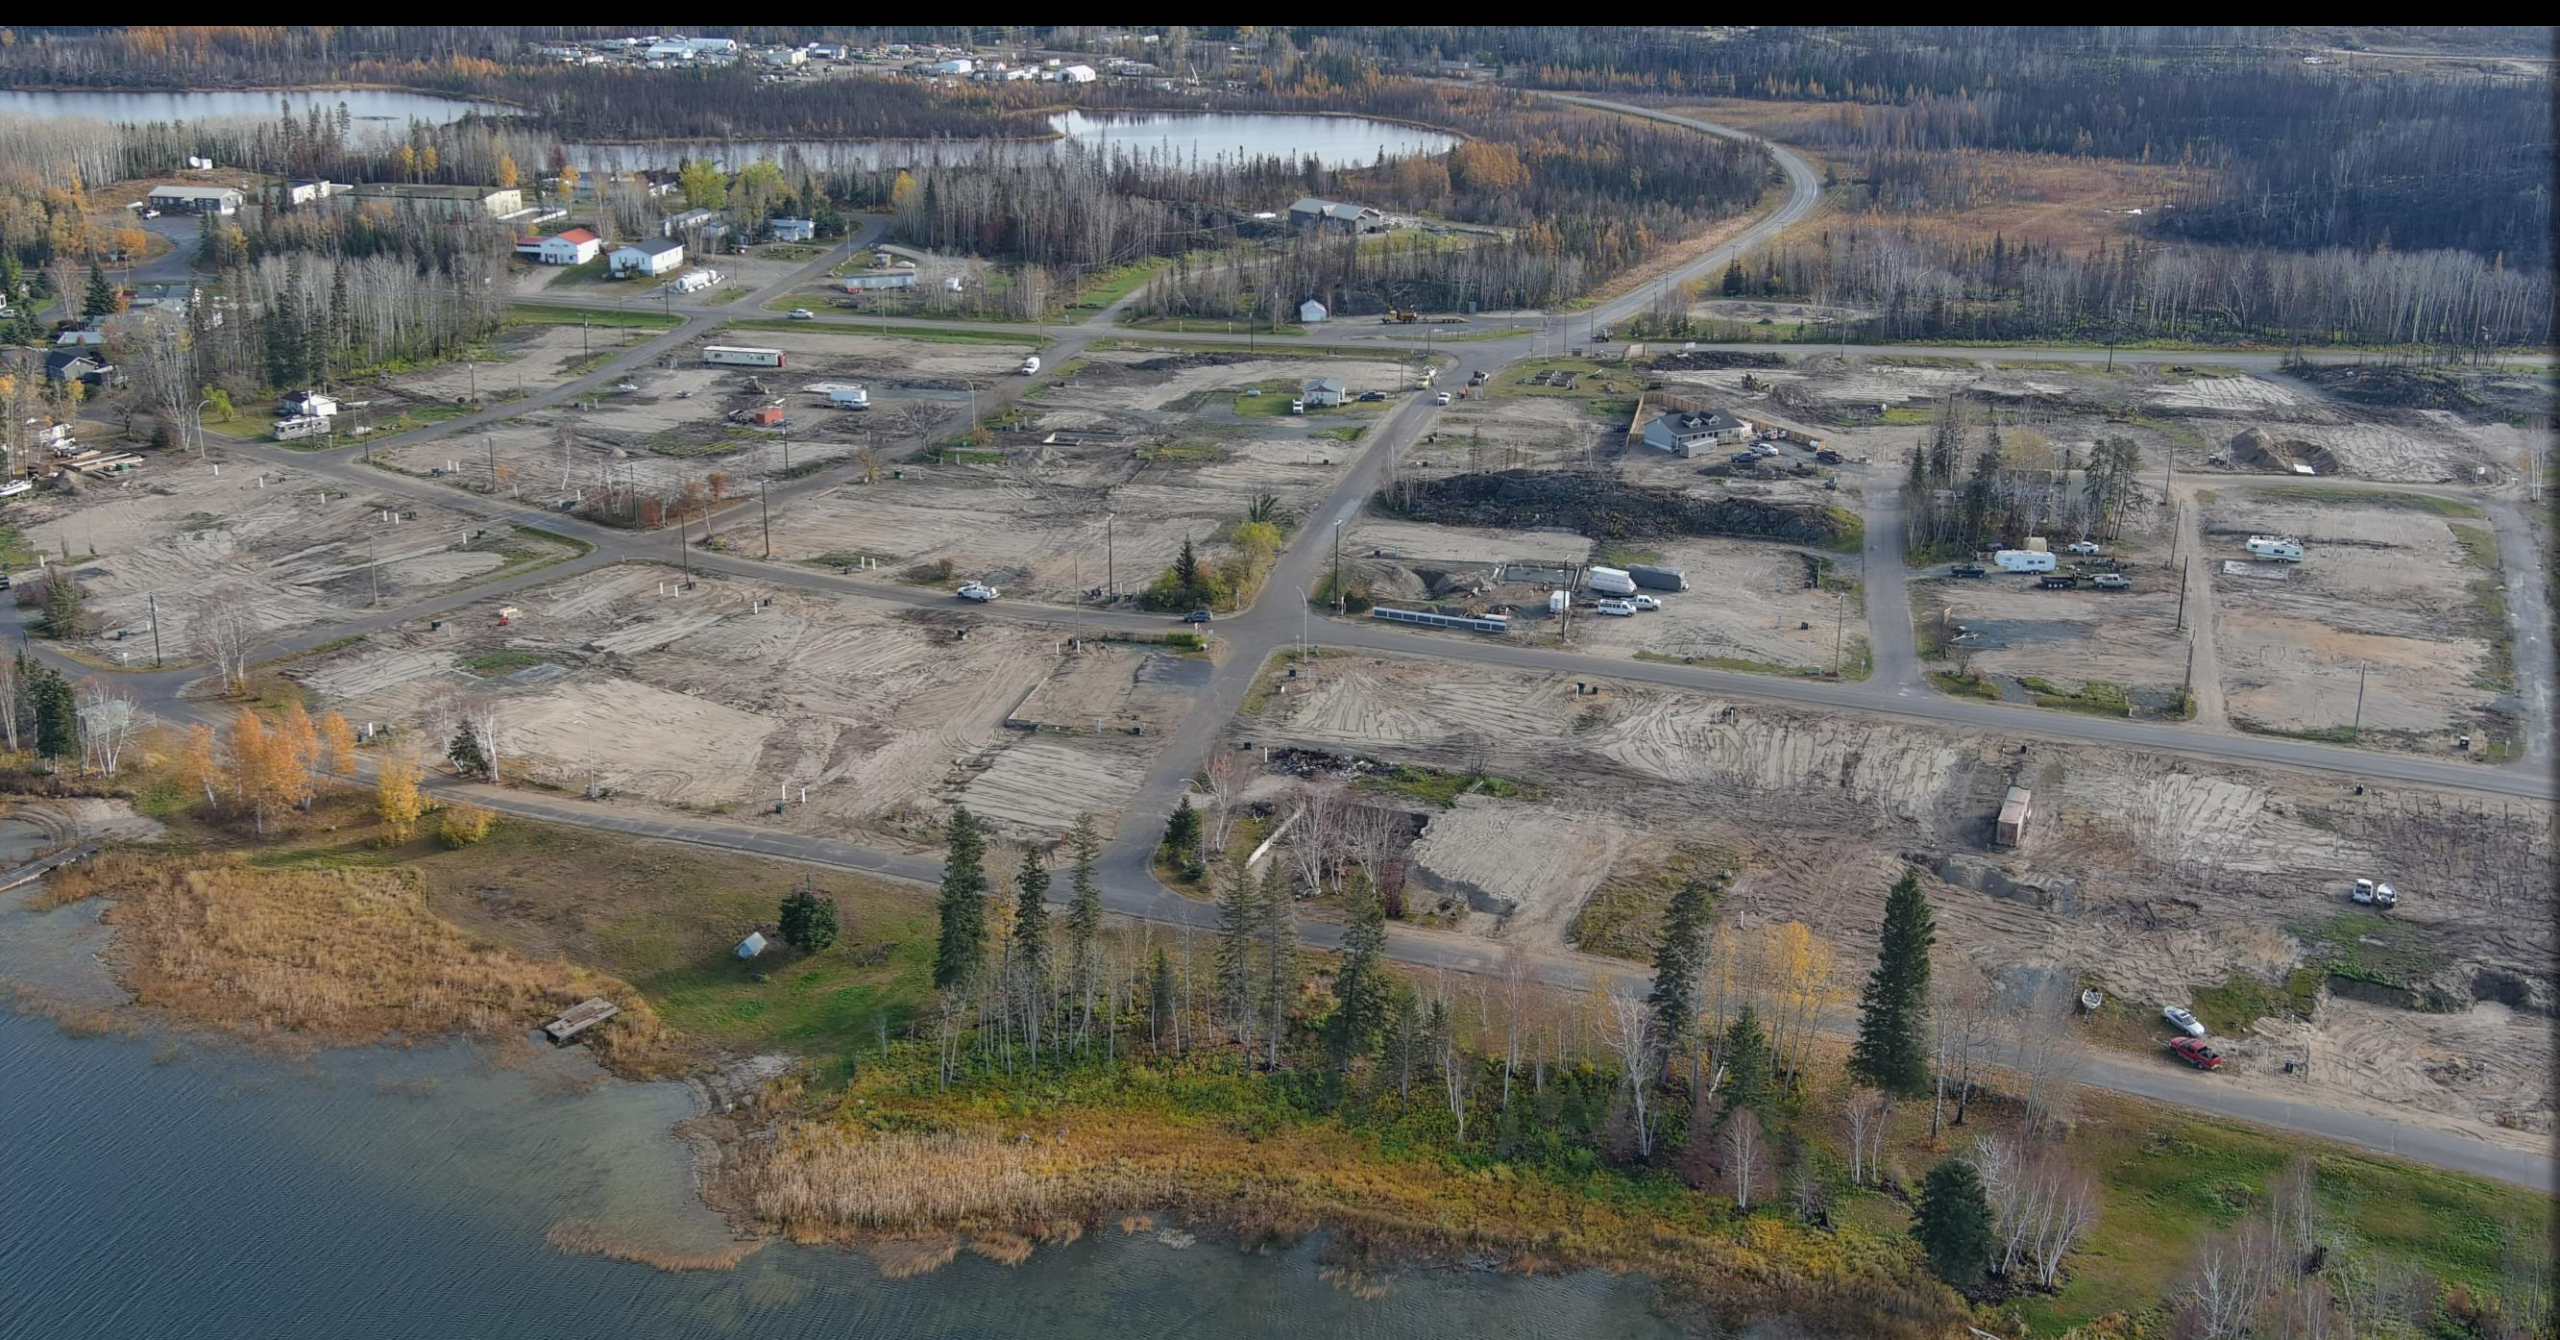
Northern Village of Denare Beach – October 22, 2025

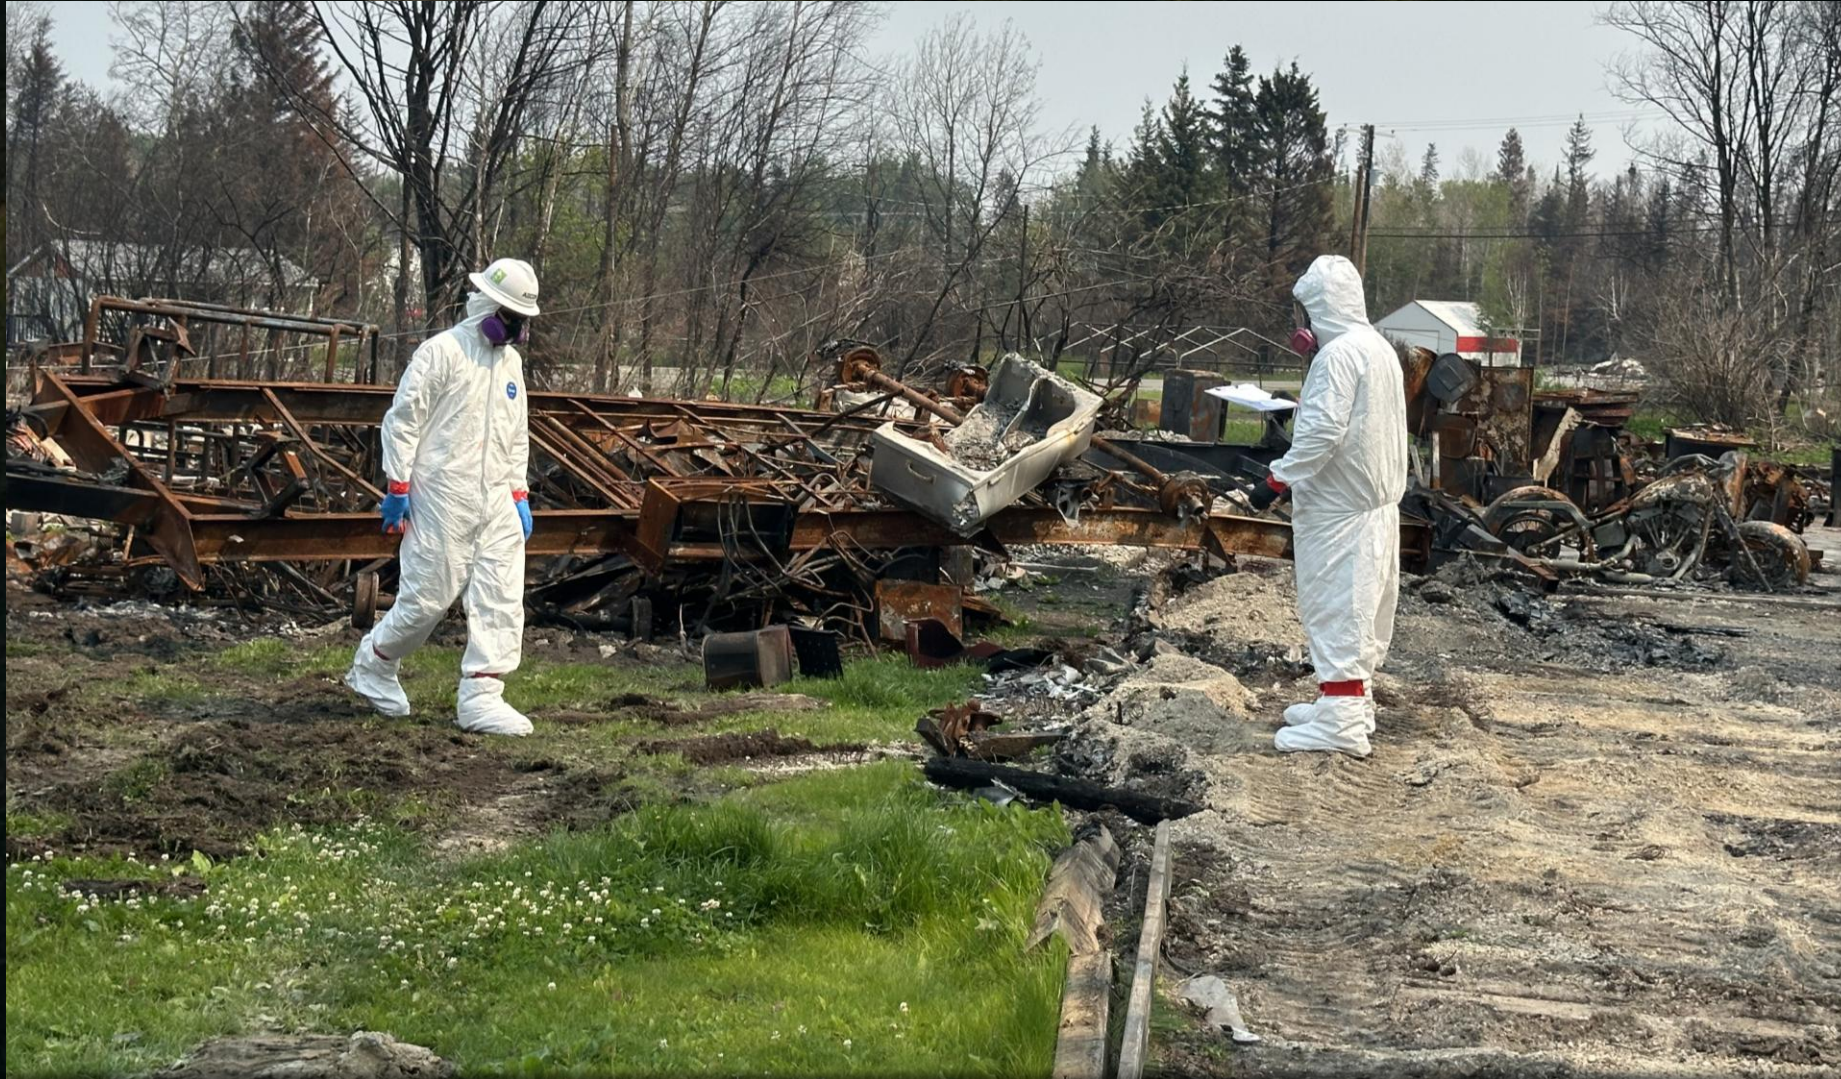
Initial Property Assessments

Asbestos Testing

- Sampled each structure to determine if asbestos was present.
- 42 properties tested positive for asbestos containing materials.

Pre-Assessments

- Documented pre-cleanup conditions of each property / parcel.
- Determined and marked hazards on each property (Acetylene tanks, propane tanks, etc.)
- Completed in teams of two – one painting and marking hazards / features, one completing a sketch of the property complete with pictures.

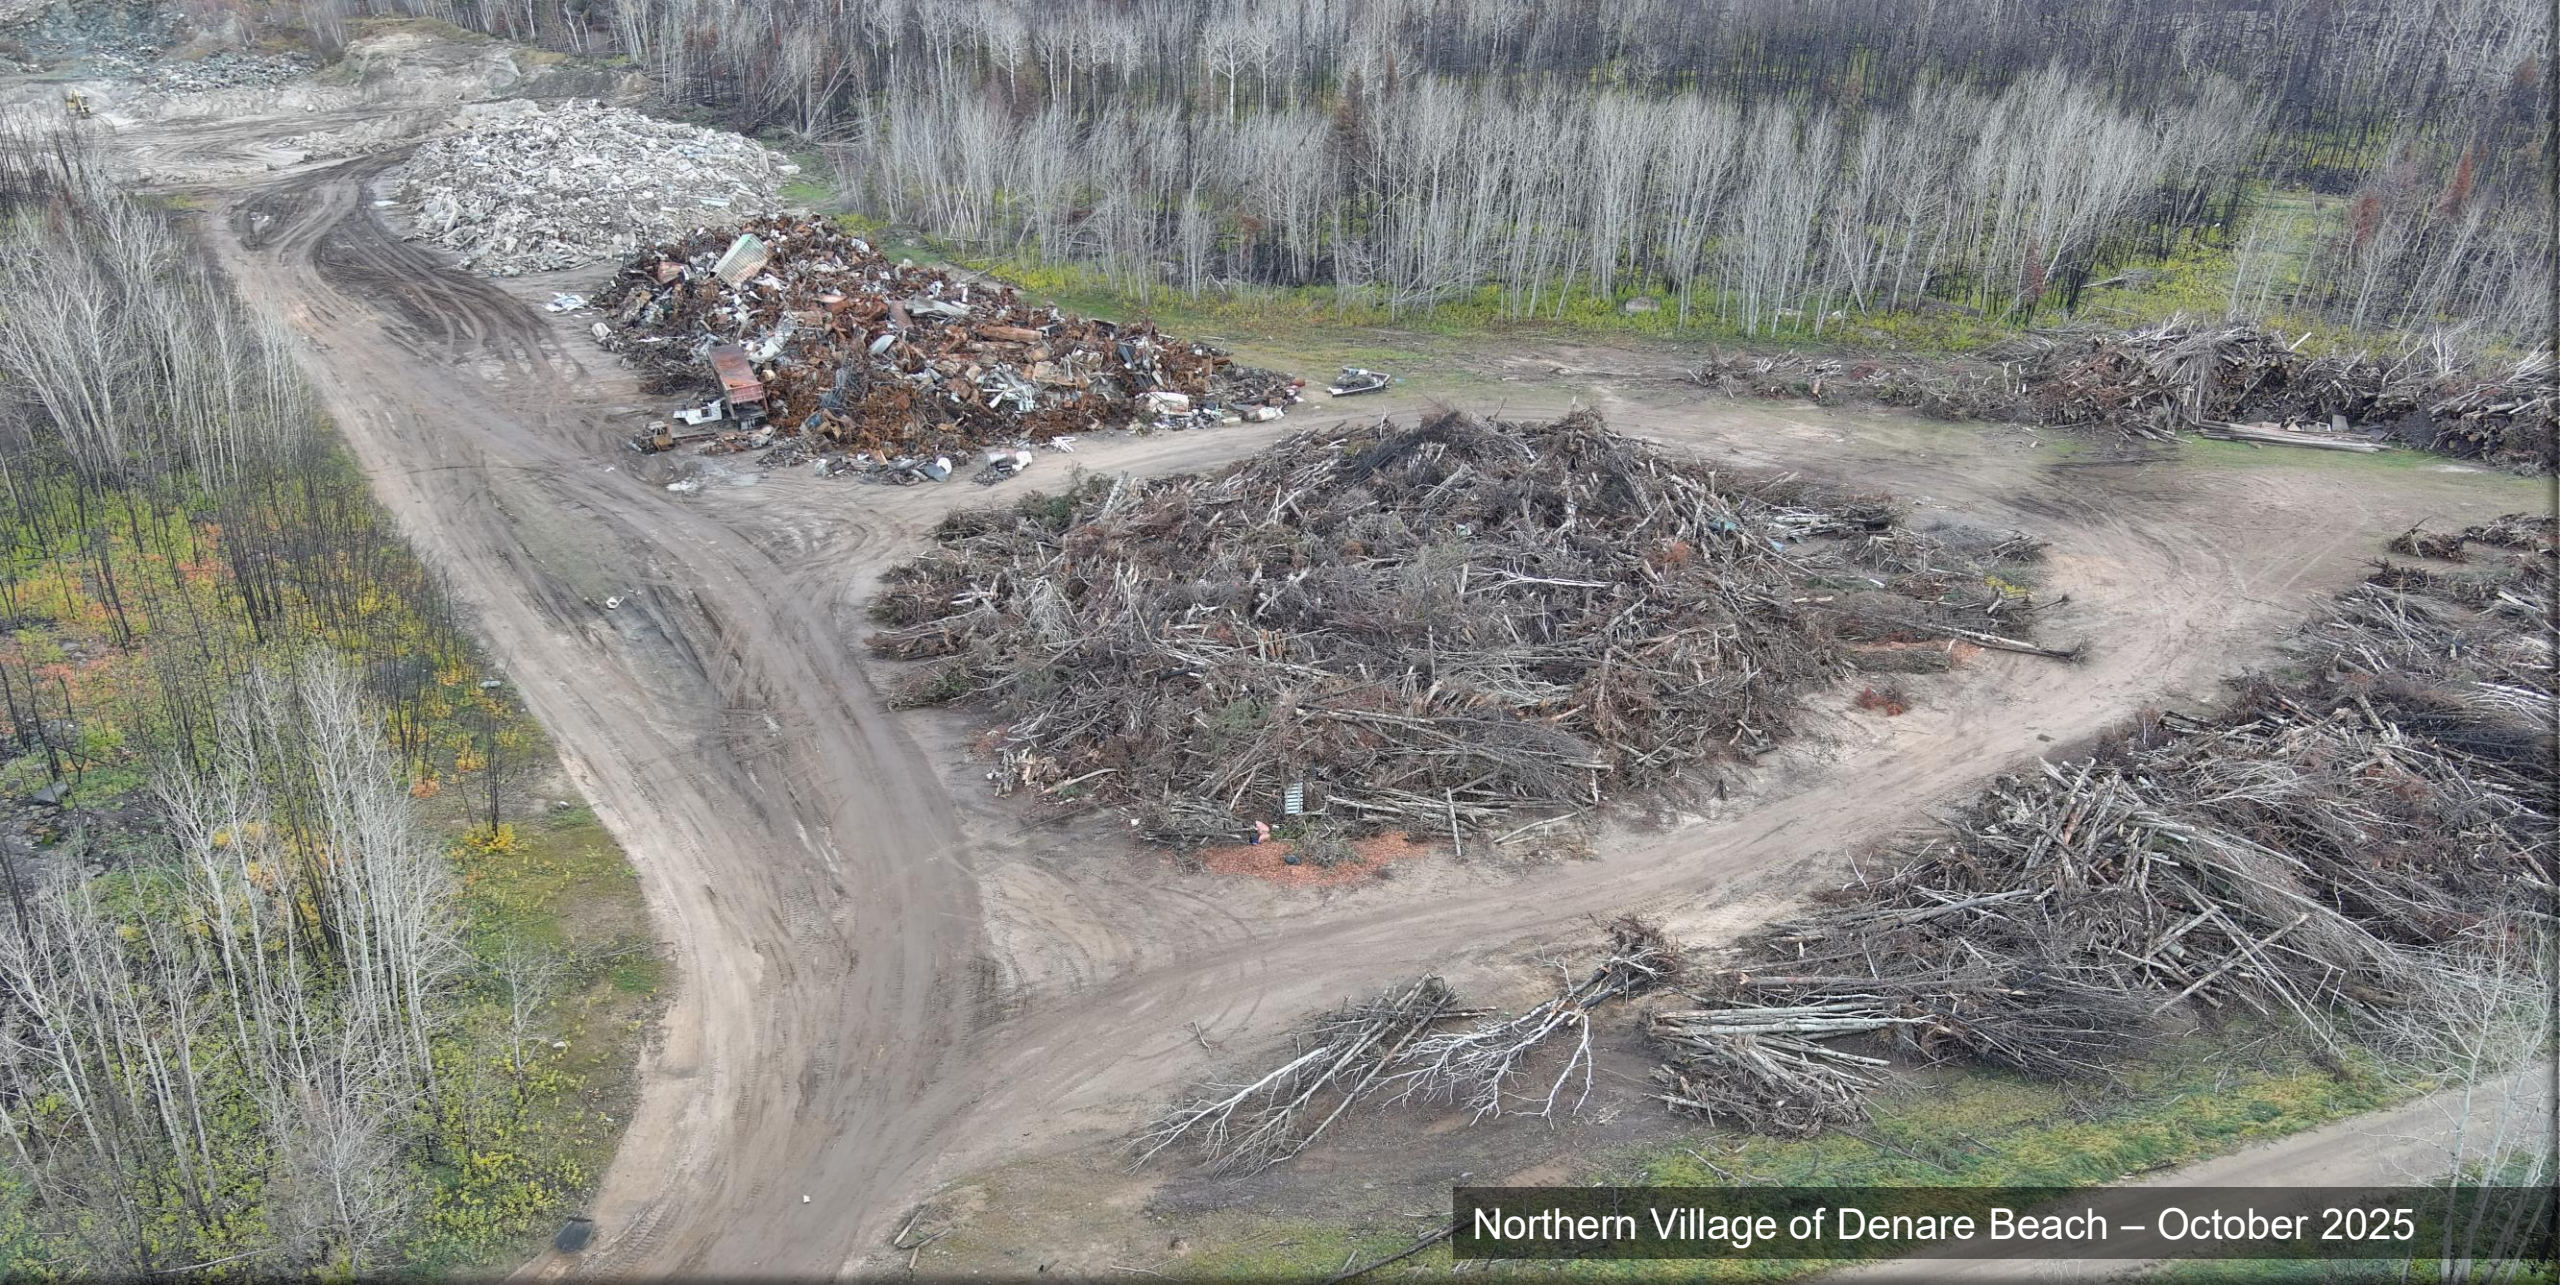
Temporary Storage Area – Historical Landfill

Northern Village of Denare Beach – October 2025

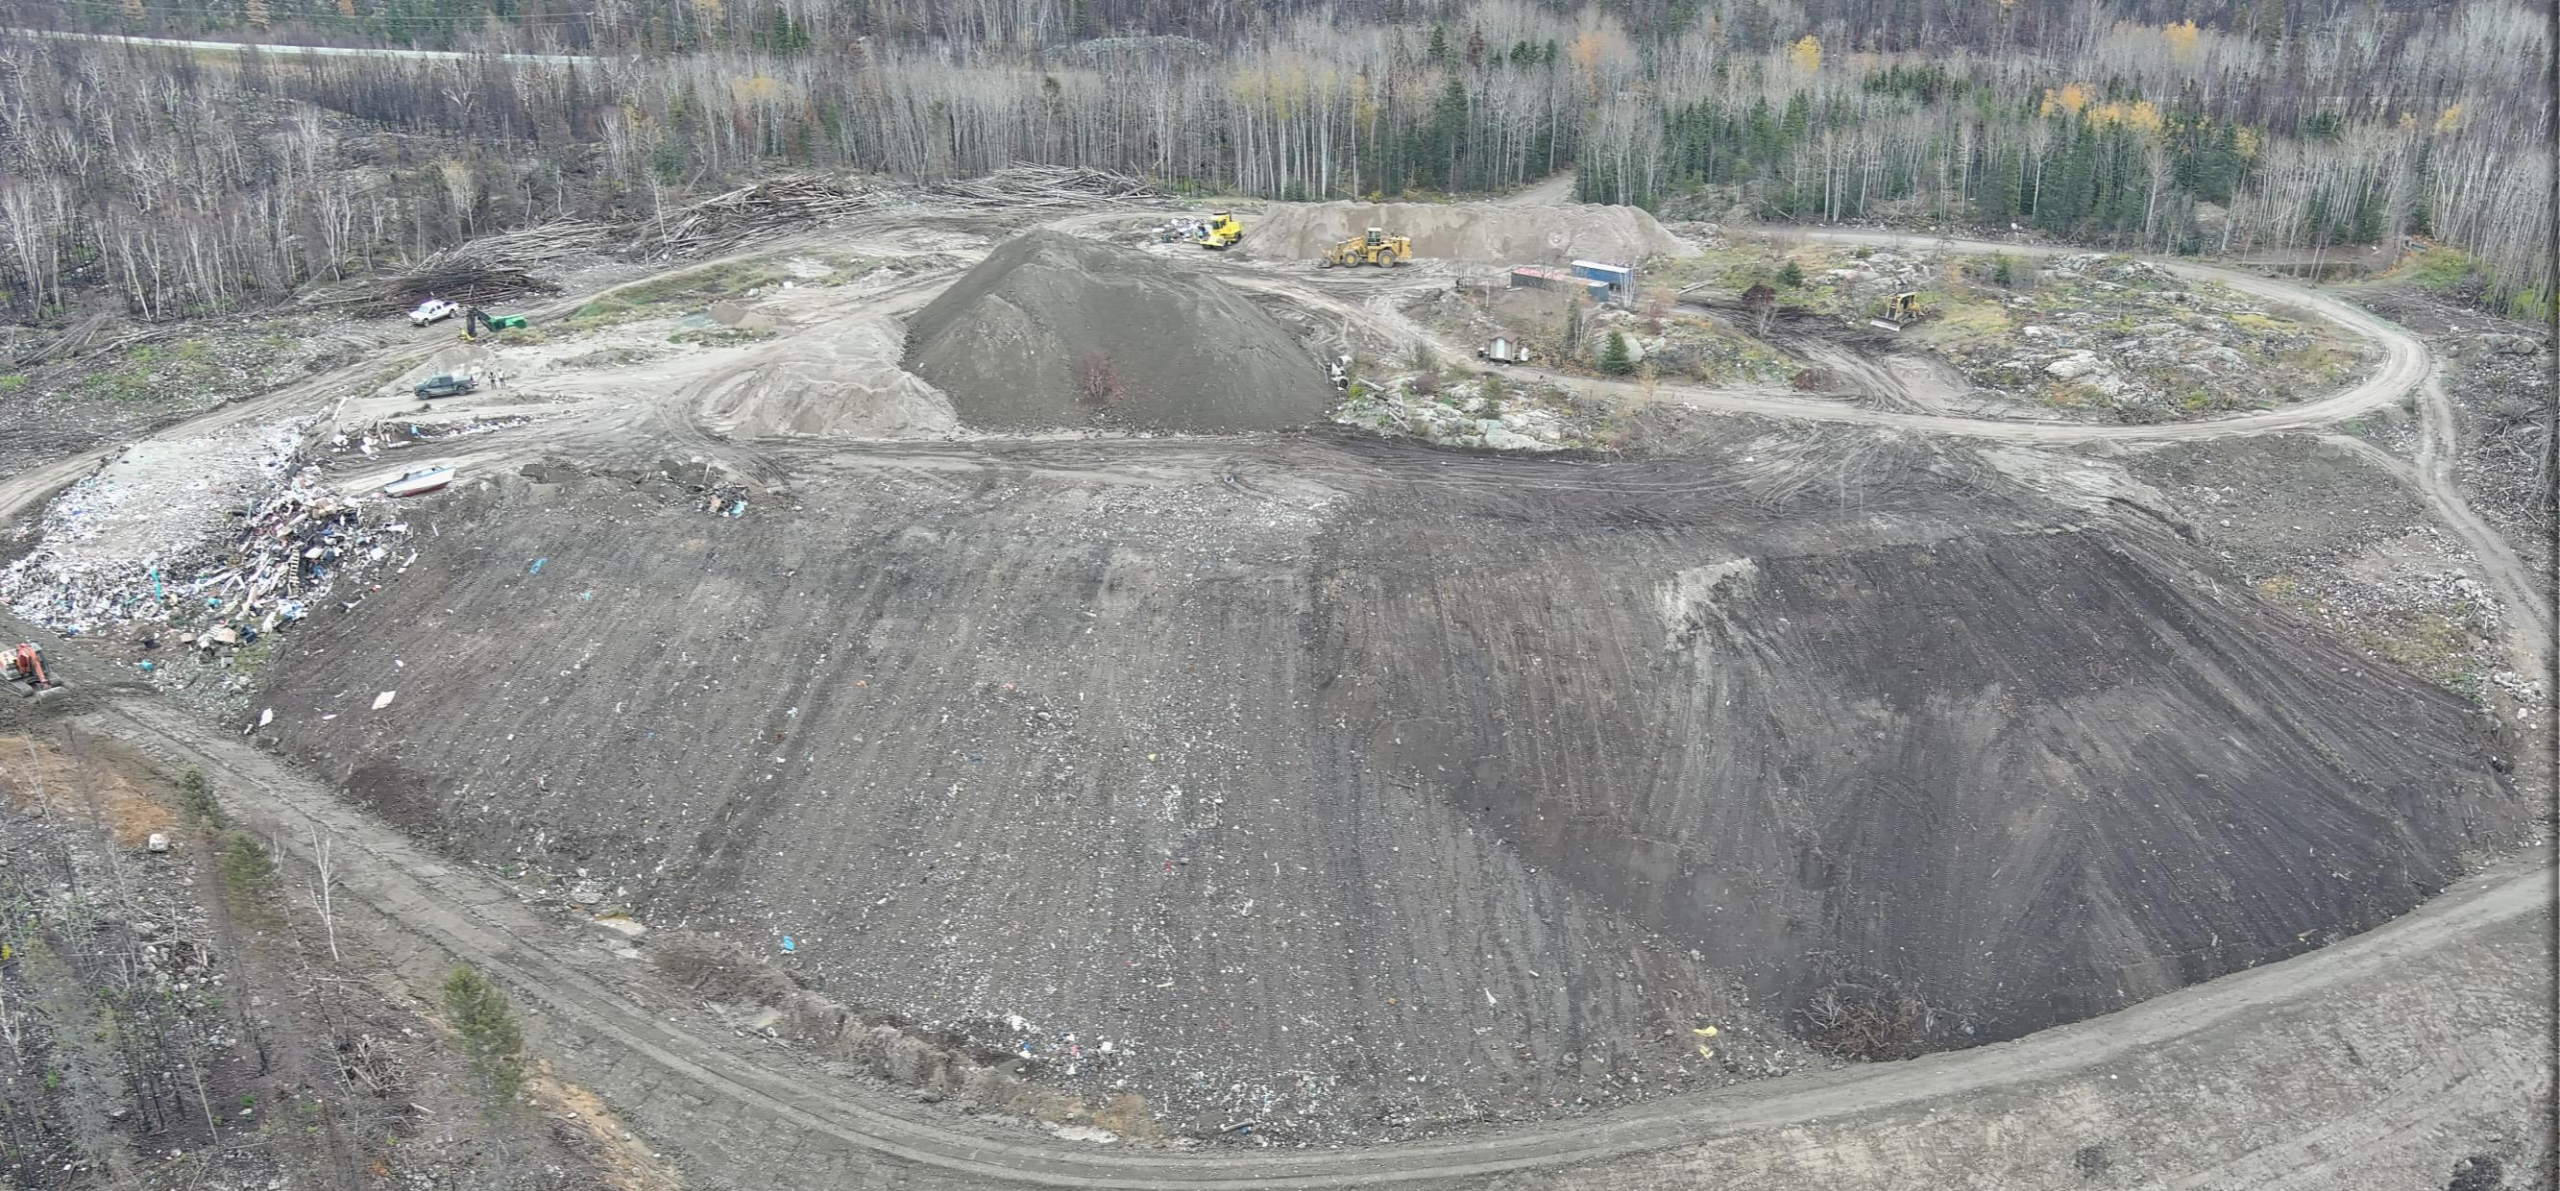
Denare Beach Landfill Expansion Area

Northern Village of Denare Beach – October 2025

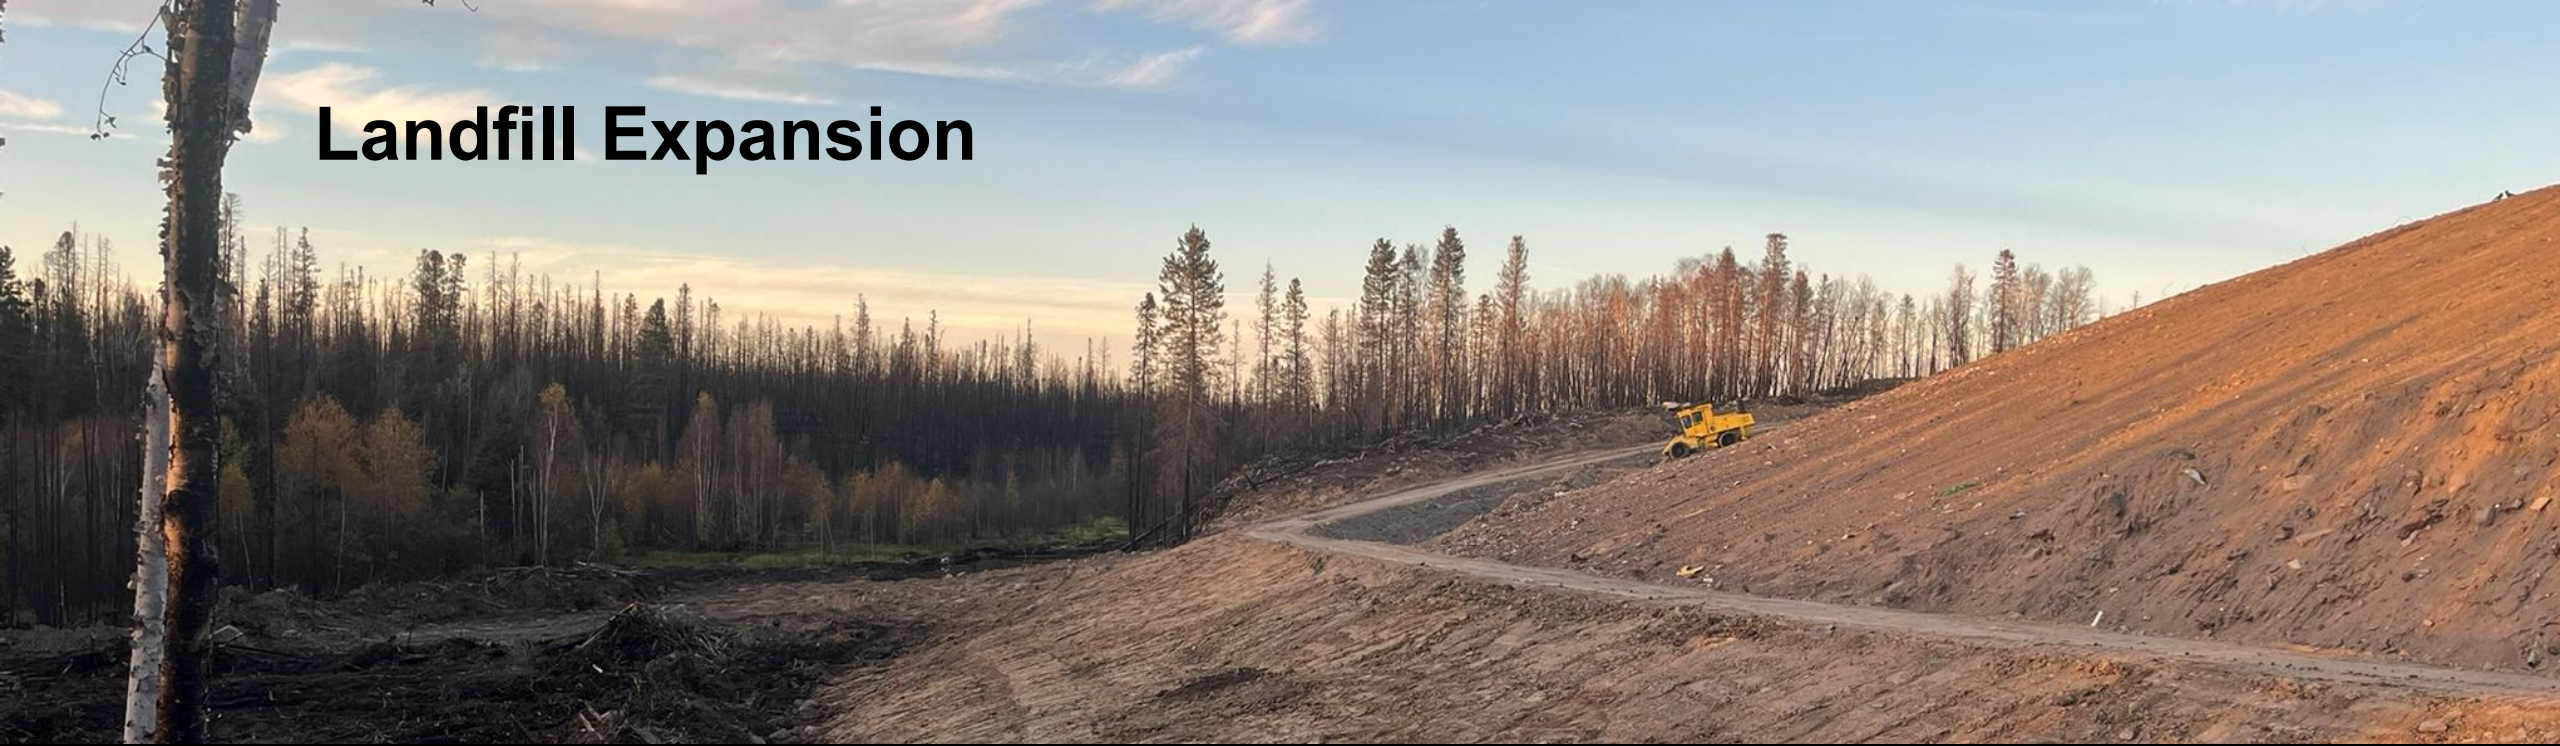
Landfill Expansion

**8.5 years
of waste**

In 4 months

- Landfilled 25,600 m³ of ash and debris.
- Local contractors mobilized quickly to the landfill to construct the containment berm and compact the ash and debris.
- The containment berm and earthen final cover used 16,800 m³ of imported clay

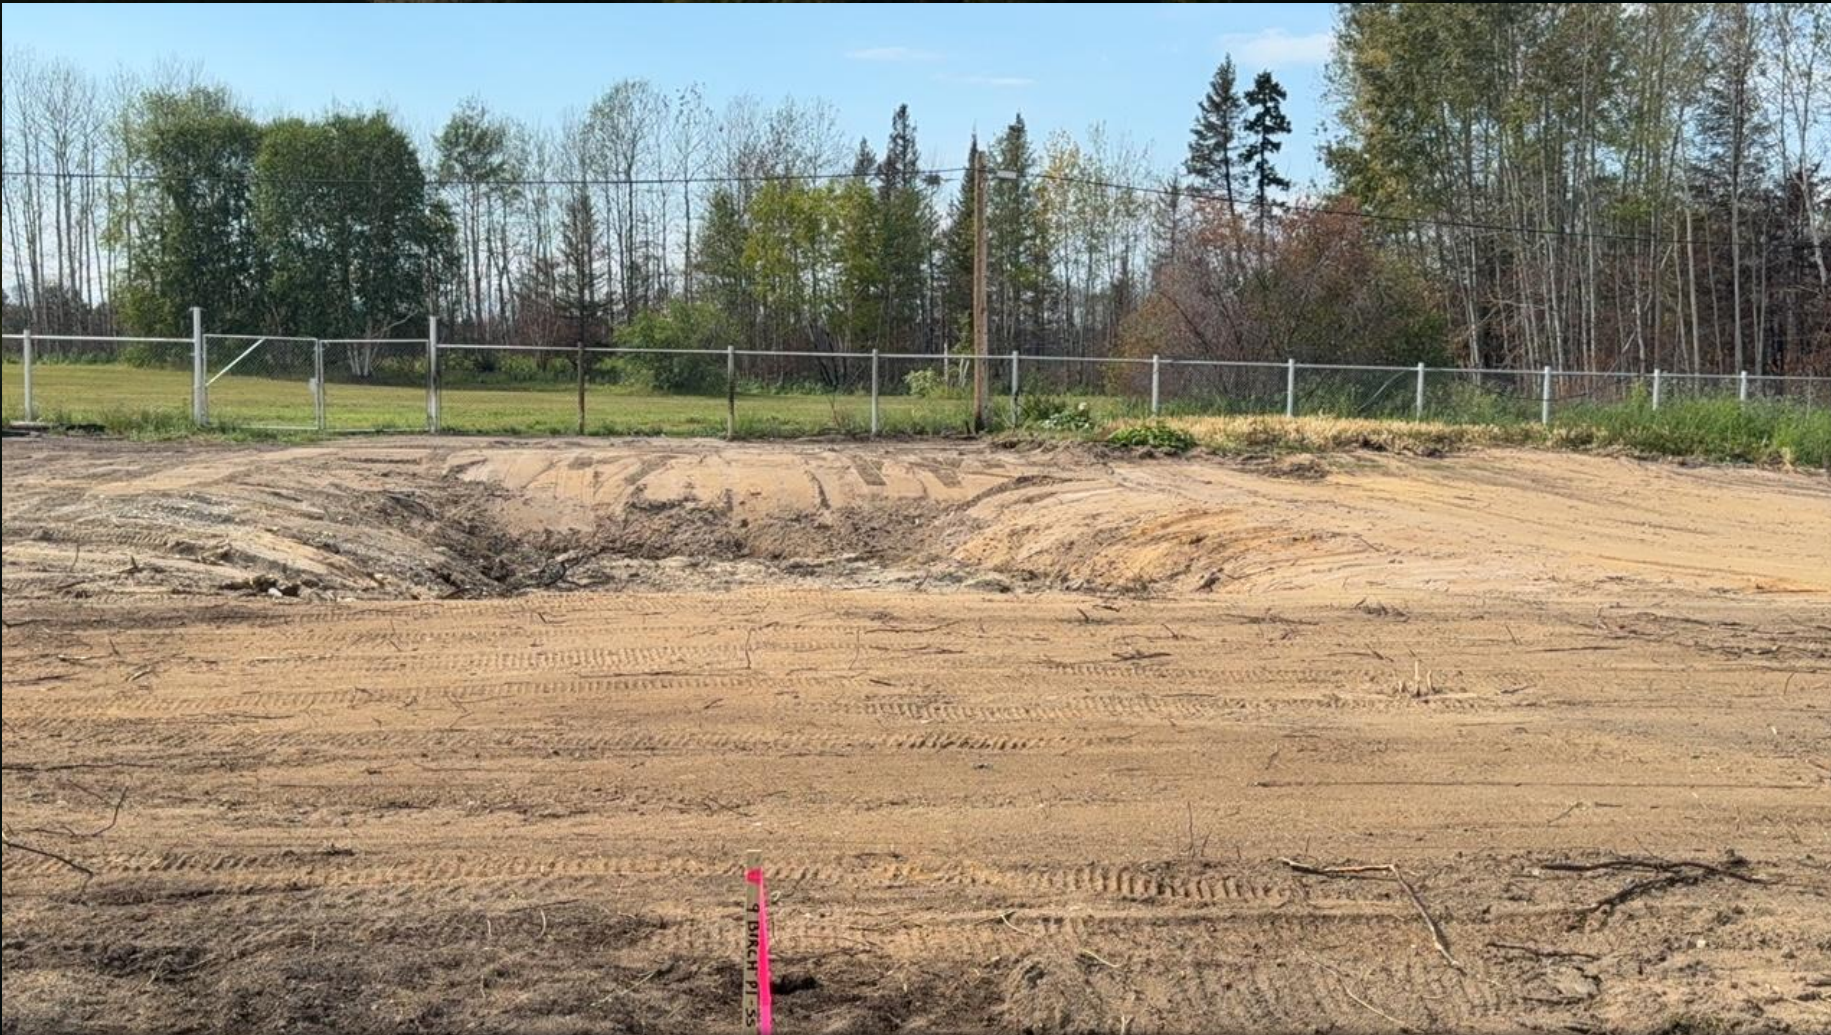
Confirmatory Soil Sampling

- Completed after primary debris removal, and walkthrough of property.
- Taken to determine if contamination is still present.
- Tested for salinity, metals, and Polycyclic Aromatic Hydrocarbons (PAH's).

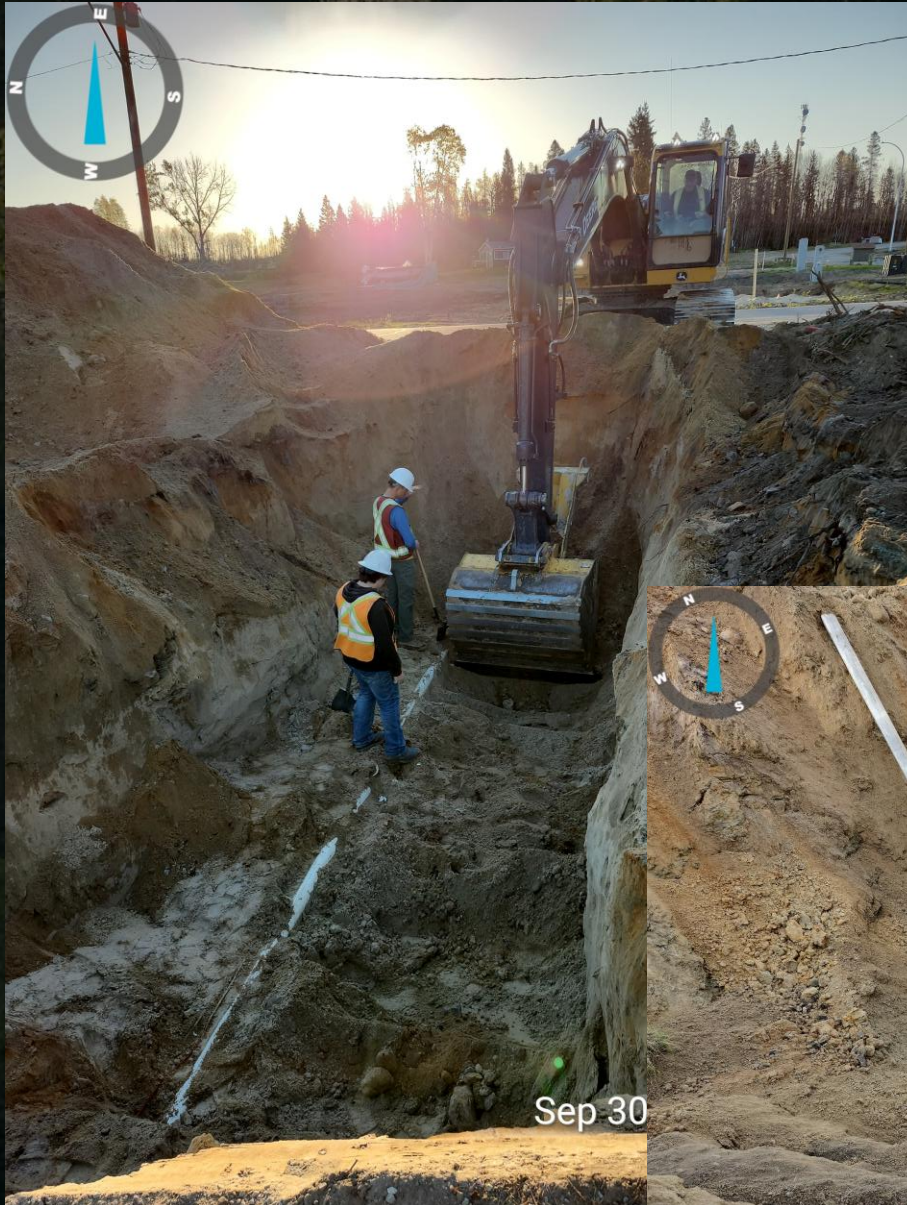
Sewer and Water Service Terminations

- Completed after passing confirmatory soil sample.
- Purpose:
 - Protect town infrastructure.
 - Protect groundwater and surface water.
 - Reduce safety hazards to cleanup crews and public.
 - Locating and marking services.

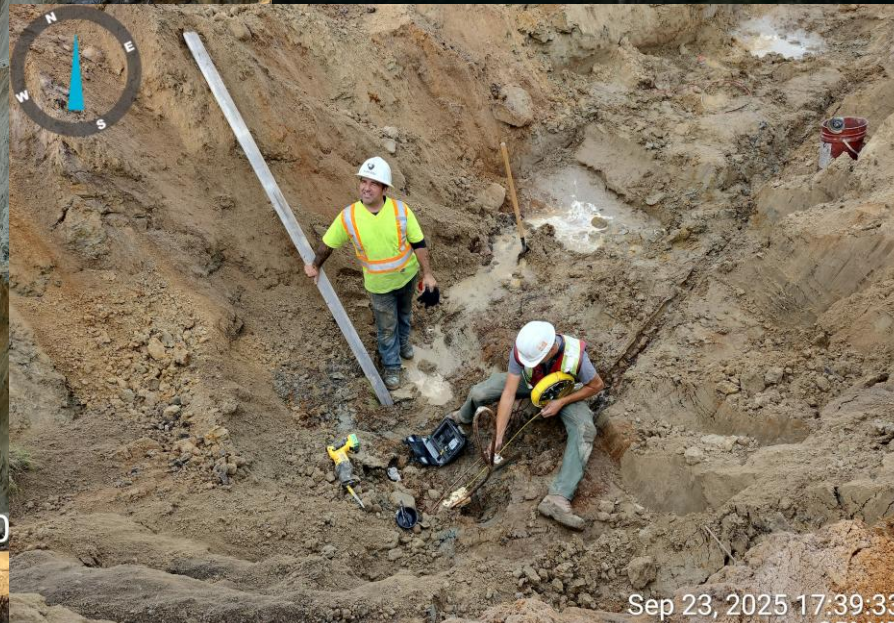
Inspected sewer services to determine their condition.

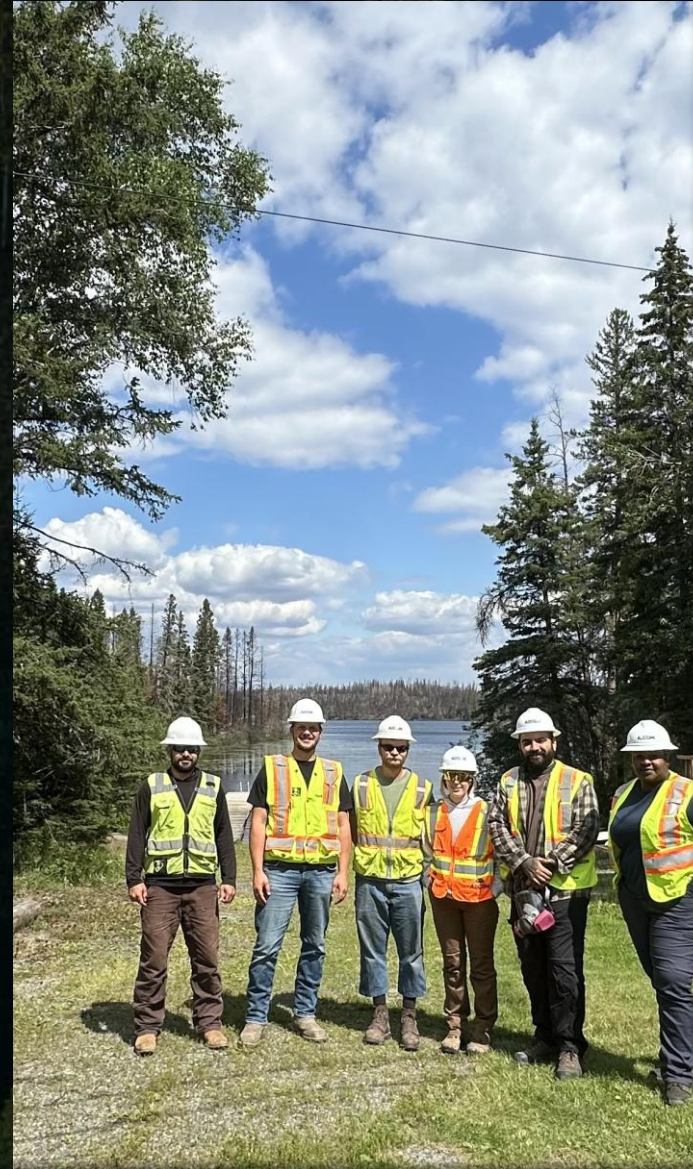
- Completed 223 Individual Property Reports
- Describe general debris removal and environmental activities conducted at each property
